CALSPAN ON-SITE AMBULANCE CRASH INVESTIGATION

SCI CASE NO.: CA12002

VEHICLE: 2012 FORD ECONOLINE 350 / MEDIX TYPE II AMBULANCE

CRASH DATE: JANUARY 2012

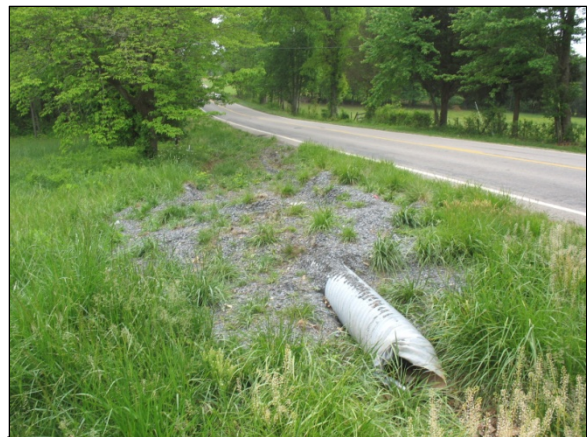
Figure 6: Southwest lookback view from the Kenworth's final rest position (*note the protruding and displaced culvert pipe*).

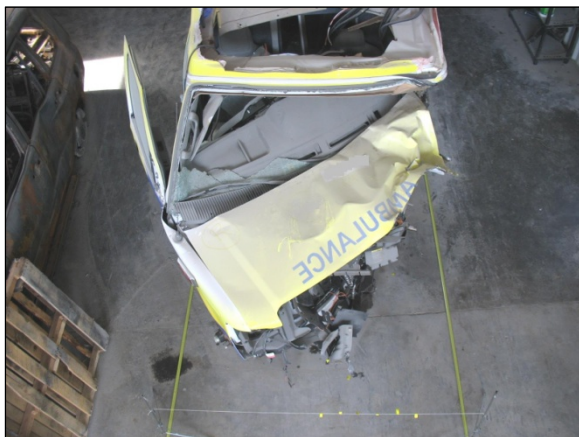
Damage to the exterior of the ambulance from the multiple-event crash was present on the frontal, left, and right planes of the vehicle. Direct and induced damage spanned the entire 174 cm (68.5 in) frontal width from bumper corner to bumper corner and included severe longitudinal deformation (**Figure 9**). Within the damage pattern, direct contact resulted in the disintegration of the grille and both headlight assemblies, with separation of the bumper beam and left front axle as well as deformation to the hood, left front fender, left A-pillar, left front door, and left B-pillar. This resulted in the severe intrusion into the passenger compartment of frontal components (**Figure 10**).

Figure 9: Overhead view of the severe frontal plane damage to the Ford/Medix Type II ambulance.

The Collision Deformation Classification (CDC) assigned to the ambulance for the frontal (Event 1) damage pattern was 12FYAW6. No WinSMASH calculations were computed because both vehicles were not within the scope of the model's parameters. The Estimated Delta-V was greater than 55 km/h (34.2 mph).

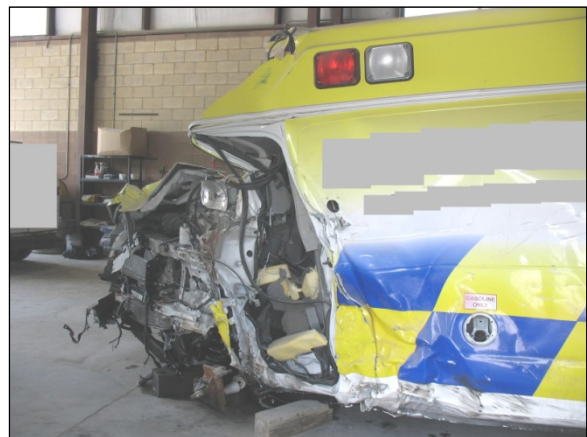
Figure 10: Left plane of the Ford/Medix Type II ambulance and the Event 1 damage pattern.

Longitudinal deformation associated with the frontal event displaced the left A-pillar and left front door. During the crash, the left front door buckled outward at its center, though the latch remained engaged against the striker. Thus, the left front door was removed post-crash by emergency response personnel using hydraulic rescue tools, resulting in further post-crash deformation to the A- and B-pillars. It should be noted that the left front door was not with the vehicle at the time of the SCI inspection.

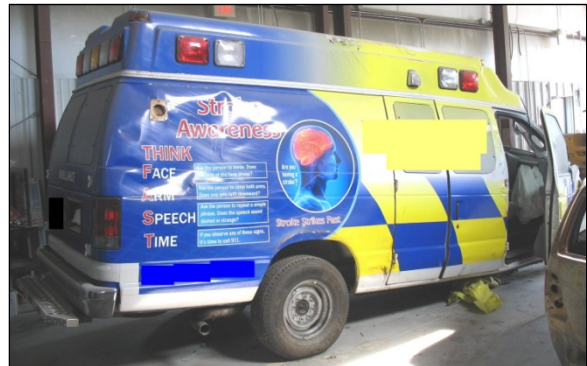
Right plane damage associated with the rollover sequence (Event 2) consisted of minor body surface deformation and abrasions (**Figure 11**). This included an area of frictional abrasions and minimal deformation to the molded fiberglass shell of the ambulance's raised roof, in the typical area of a vehicle's right roof side rail. Surface abrasions were present across the entire right side plane, aligned in a diagonal direction from the front lower corner toward the rear upper corner of the right plane. No significant crush was associated with the minor severity, one quarter-turn rollover event. The CDC assigned to the ambulance for the rollover (Event 2) damage pattern was 00RDAO2.

Figure 11: Right plane of the Ford/Medix Type II ambulance and the Event 2 damage pattern.

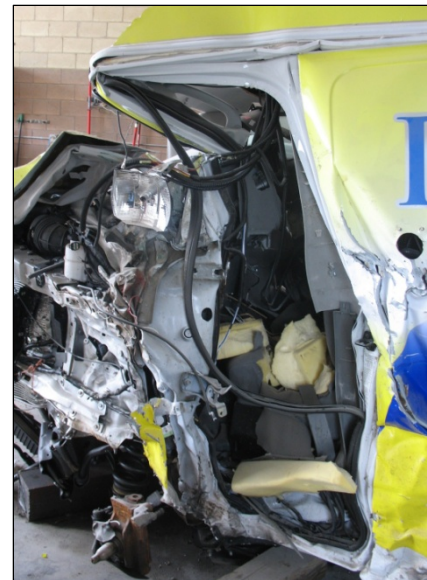
The interior of the ambulance's cab sustained significant damage as a result of the crash, including severe intrusion associated with the exterior Event 1 crash forces. The A-pillar was deformed rearward with such magnitude that the upper A-pillar was nearly parallel with the roof side rail and the lower A-pillar area was engaged against the forward aspect of the left front seat cushion. To document the longitudinal displacement of the left A-pillar, measurements were referenced to the right B-pillar of the ambulance and compared to an exemplar chassis cab. These longitudinal measurements highlighted rearward displacements of the left A-pillar (**Figure 12**) of 44 cm (17.3 in) at sill level, 52 cm (20.5 in) at the lower door hinge, 64 cm (25.2 in) at the upper door hinge, 67 cm (26.4 in) at the beltline, and 13 cm (5.1 in) at the junction with the right roof side rail.

Figure 12: Deformation to the left A- and B-pillars of the Ford's cab.

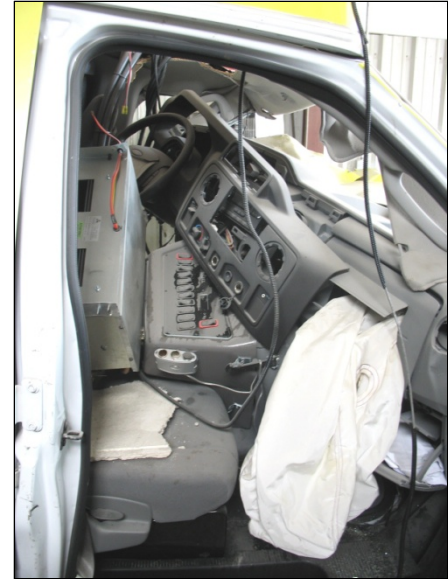
The severe interior intrusion within the ambulance cab was heavily biased to the left side. The entire instrument panel and steering column were displaced longitudinally, such that the steering wheel rim was loosely engaged against the upper aspect of the left front seat back. The floor, pedals, and toe pan were also displaced and intruded longitudinally into the interior. There was gross deformation and deflection to the floor under and surrounding the driver's seat. Due to the rearward displacement of the floor and surrounding components, the left front seat back was deformed forward and was engaged against the bulkhead wall separating the cab from the patient compartment.

Occupant contact points within the cab were located on the knee bolster and instrument panel from interaction with the driver during the crash. These included distributed abrasions and blood transfer; however, due to the removed and unavailable status of the left front door, as well as the prolonged extrication process associated with the removal of the deceased driver's body, the correlation of specific contact points to the occupant's kinematics could not be determined. The severe intrusion of the instrument panel into the front row of the cab is depicted in the crossing-view shown in **Figure 13**.

Figure 13: Structural intrusion into the cab of the Ford.

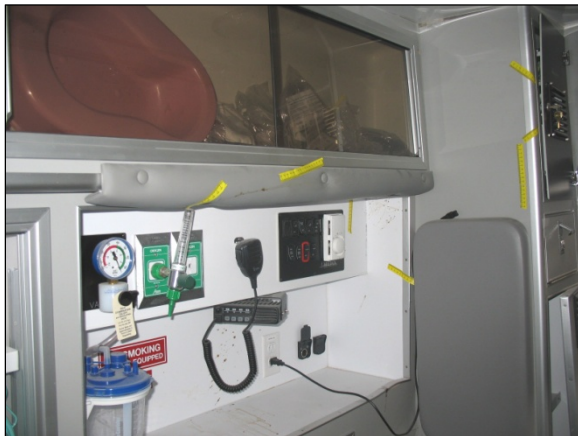
Within the patient compartment of the ambulance, interior damage was attributed to occupant and displaced unsecured cargo contact. There was no intrusion into the patient compartment of the ambulance as a result of the multiple event crash, nor did it sustain integrity loss. This damage was present primarily to the interior front, left, right, and top planes. The bulkhead was slightly displaced as a result of induced structural buckling relating to the frontal (Event 1) impact. Occupant contact attributable to interaction with the stretcher occupant included a pattern of pooled blood and hair on the ceiling and right wall above the bench seat, scuffs and abrasions to the rearward-facing surfaces of the bulkhead, and a longitudinal abrasion/depression to the padded corner surface above the countertop on the left interior plane. Contact attributable to the male EMT was limited to loading depressions to the Captain's Chair seat back. These interior contact points are depicted in **Figures 14** and **15**.

Figure 14: Left plane and bulkhead area occupant contact locations within the patient compartment.

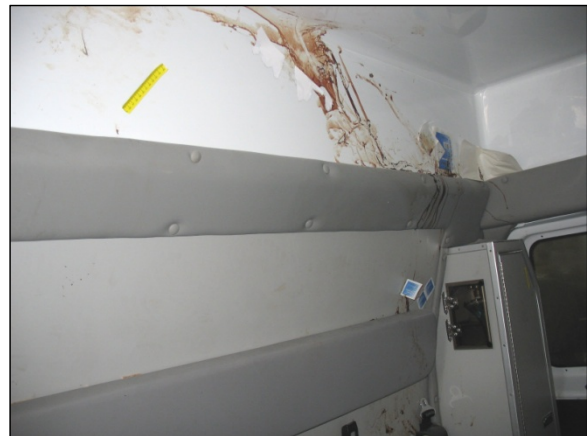
Figure 15: Occupant contact and blood transfer on the ceiling and right interior plane of the ambulance.

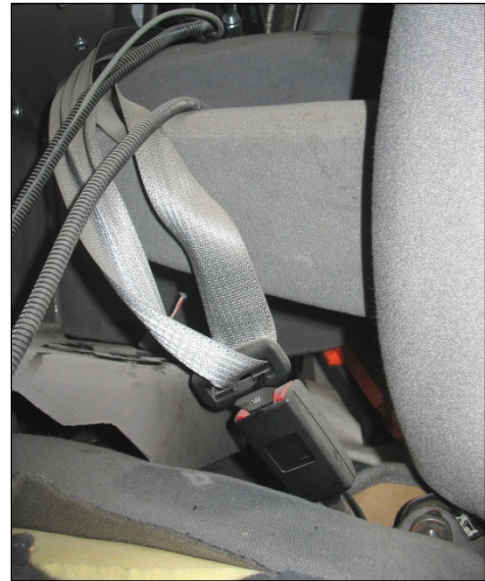
Figure 16: Cut portion of the driver's safety belt webbing gathered within the latch plate.

At the time of the SCI inspection, the driver's safety belt webbing was cut at the upper B-pillar and box-mount anchor locations. The latch plate remained engaged within the buckle, with the cut portion of the webbing looped through the belt path (**Figure 16**). The webbing was gathered in the forward aspect of the latch plate, and also displayed stretching along its entire exposed length. This evidence confirmed belt usage by the driver at the time of the crash. The patient compartment belt systems displayed minor to no evidence of historical use; therefore, restraint usage by the male EMS crewmember could not be confirmed or disputed based solely on the post-crash condition of the Captain's Chair lap safety belt system.

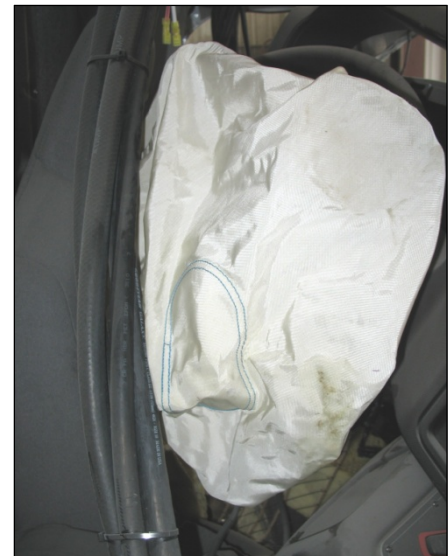
The cab of the ambulance was equipped with a frontal air bag system for supplemental restraint. This system consisted of advanced dual-stage air bags available for the driver and front right passenger, mounted within the steering wheel hub and top instrument panel. Both air bags were installed by the original manufacturer and had not required any service/maintenance prior to the crash. The frontal impact (Event 1) resulted in the deployment of both frontal air bags within the ambulance. Inspection of the driver's steering wheel hub-mounted air bag was limited by the engagement of the steering wheel rim against the left front seat back (**Figure 17**).

Figure 17: Deployed driver air bag within the Ford.

The driver's frontal air bag deployed through the H-configuration cover flaps without damage. In its deflated state, the air bag measured 55 cm (21.7 in) in overall diameter. Contact evidence on the air bag consisting of blood transfer and material abrasions evidenced occupant interaction. The front right passenger's air bag deployed from the top instrument panel-mounted module through the 23 cm (9 in) wide by 7 cm (2.8 in) tall H-configuration cover flaps without damage. In its deflated state, 55 cm (21.7 in) tall by 37 cm (14.6 in) wide air bag extruded 60 cm (23.6 in) rearward from the module. There was a 4 cm (1.6 in) diameter vent port located on each side of the air bag. Due to the unoccupied status of the front right seating position and the restrained status of the driver, there was no occupant interaction associated with the deployed front right passenger's air bag.

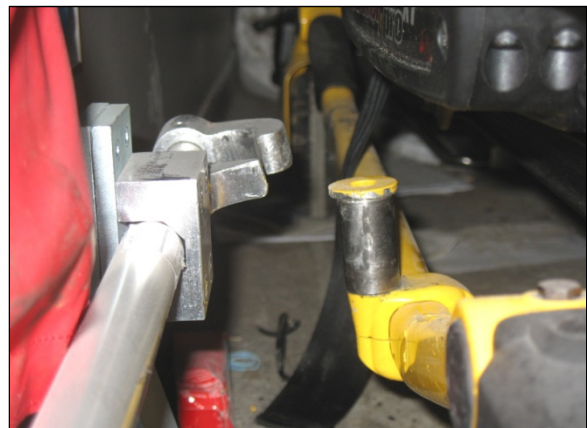
During the frontal crash event, longitudinal crash forces induced a forward trajectory to the stretcher (with respect to the patient compartment's floor). The combined mass of the stretcher and its occupant, coupled with the associated longitudinal crash forces, translated through the locking pin and frame to the locking-clamp mechanism and antler bracket. The stretcher's forward frame and guide wheels loaded the antler bracket, which restricted the forward movement of the stretcher. This created a positive moment of inertia to the stretcher, and its rear aspect began to lift vertically. This movement translated longitudinal and vertical forces on the locking clamp, which exceeded the clamp's locking force load capabilities and deformed the forward portion of the clamp vertically (**Figure 21**) as the locking mechanism released. In such a manner, the stretcher's lateral and vertical movement became unrestricted.

Figure 21: Post-crash misalignment of the locking-clamp pin and mechanism.

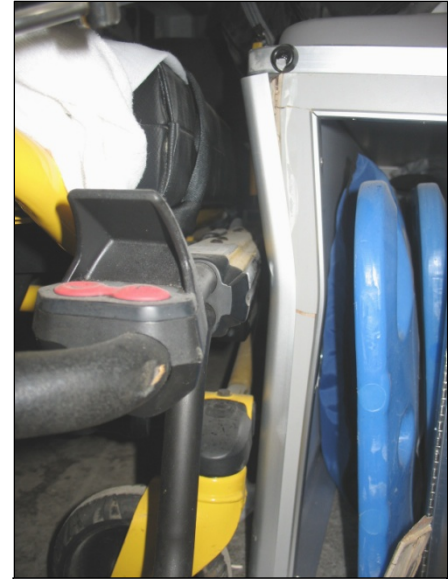
As the ambulance initiated its right side-leading rollover sequence, the force of gravity acting on the stretcher's mass induced the movement of the stretcher toward the ambulance's right plane. The locking pin departed the locking-clamp opening and the right aspect of the stretcher contacted the rear left-facing aspect of the bench seat base. This contact fractured the plywood structure and deformed the bench seat base 2 cm (0.8 in) laterally (**Figure 22**).

Figure 22: Bench seat base structure deformation from stretcher frame rail contact within the Ford ambulance.
